No Flood Damage From Storm

**Story By Larry Gomes
Pictures by Andy Thibodeau
Trail Master, Milan Trail Huggers
November 3, 2017**

Two club members conducted an inspection of the clubs off-road trails and found no damage from Monday's storm other than down trees.

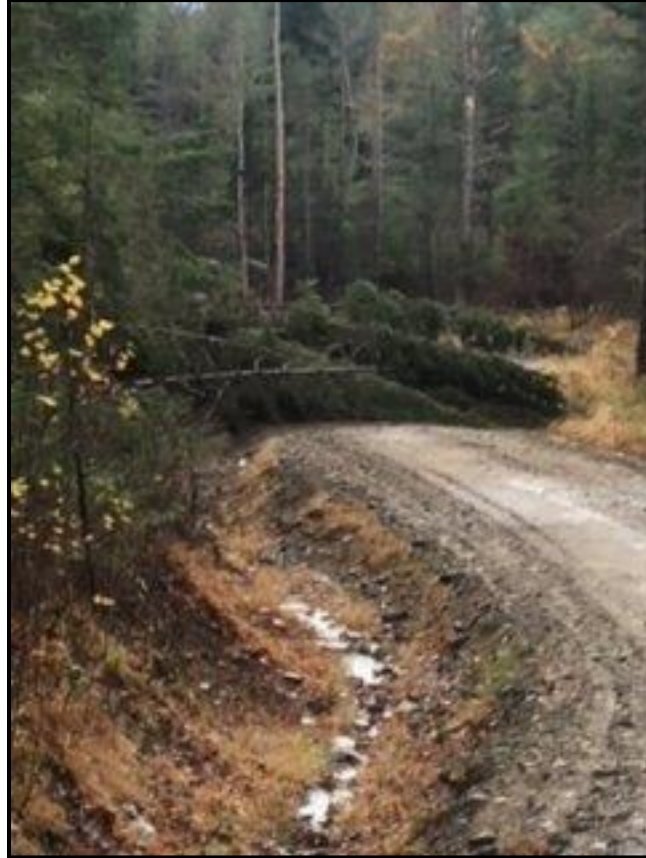
A group of large trees blocking the trail.

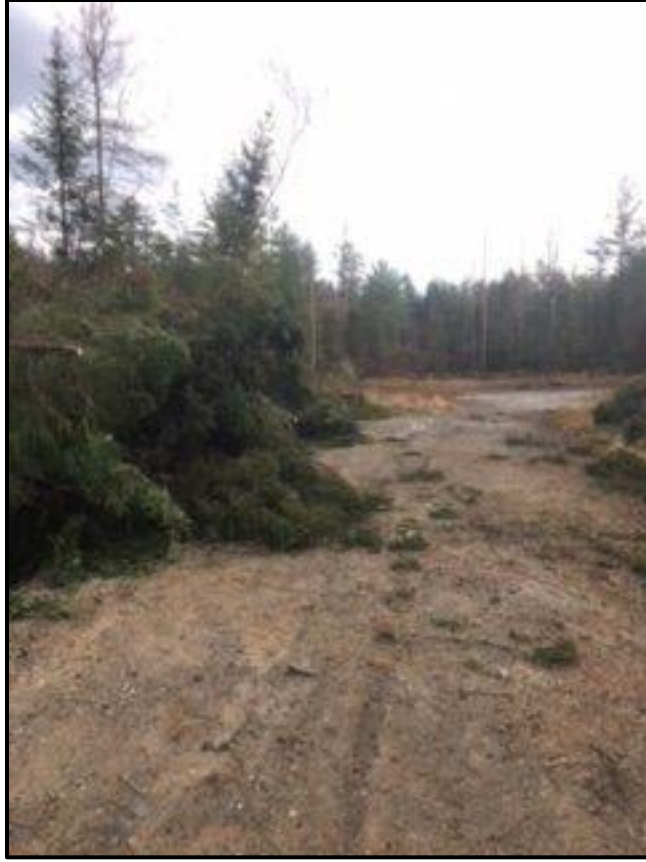
Some of the trees that still need to be cleared from the ditches on the side of the trail.

Andy said "We removed 8 or 10 good size trees and numerous smaller trees. The trail is now open from one end to the other but we will need another 4 hour work day to get the rest of the trees removed from the ditches."

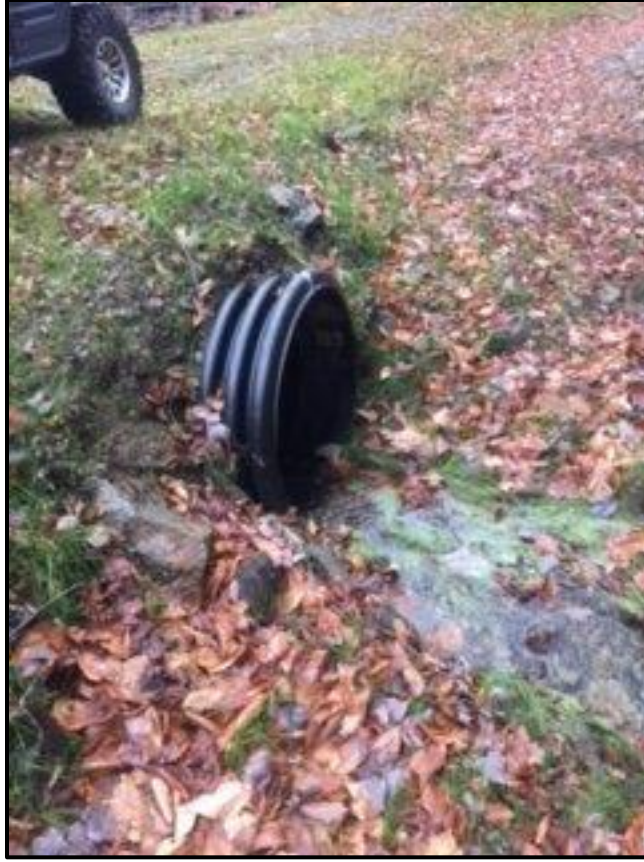
The extra-large 36" culvert donated by the NH ATV Club is doing its job.

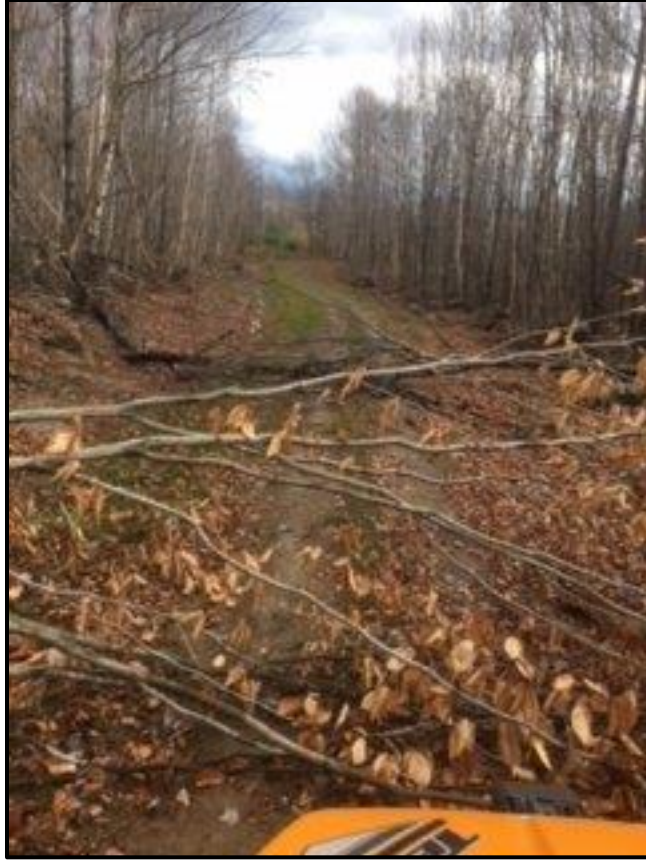
Some of the smaller trees that were cleared from the trail.

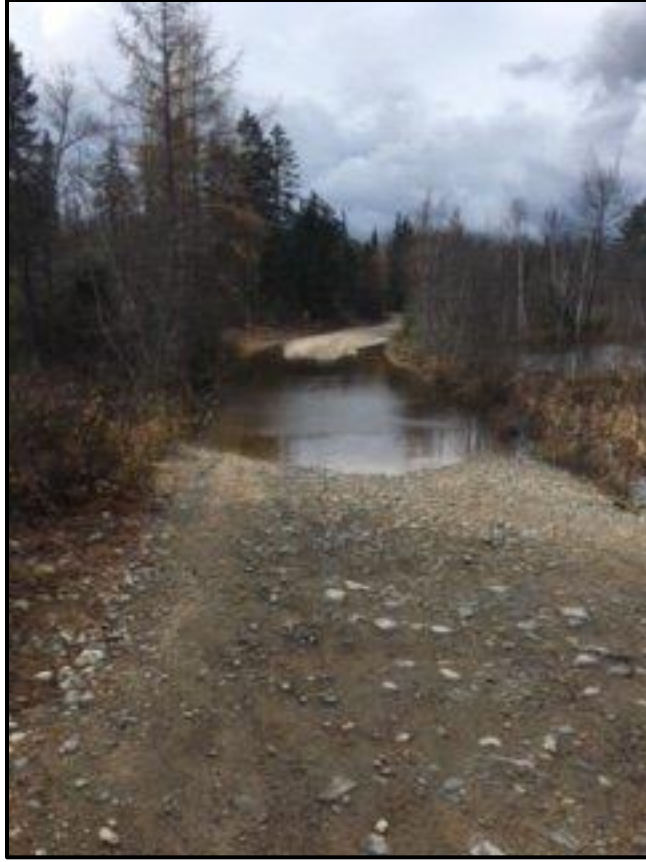
This section of Head Pond Road has wetlands on each side of the road and it always floods in heavy rain events. After a few days, the water subsides and the road is usually left undamaged.

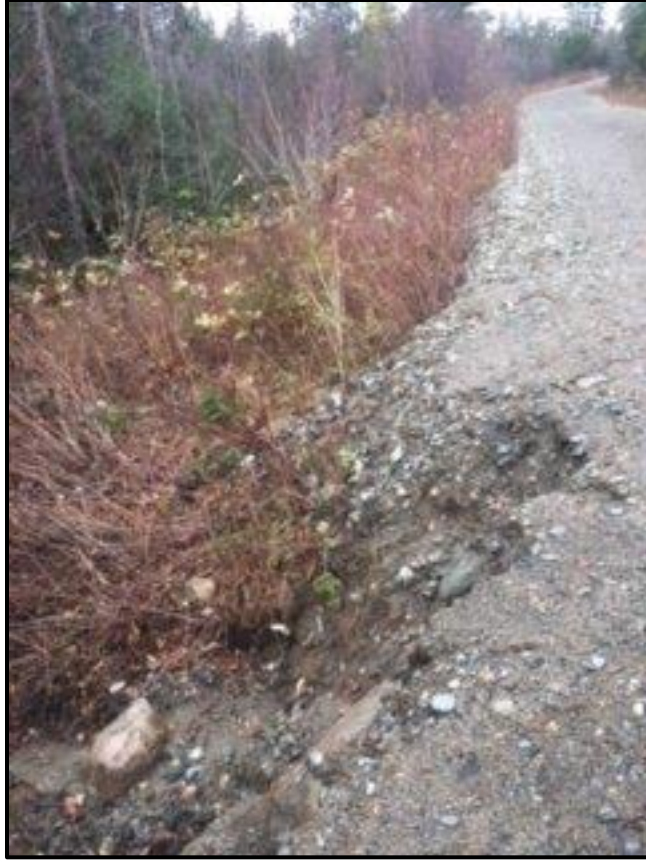
**One small washout on the existing gravel road leading up to Rt. 110B.
This will be easily fixed next spring before the trail opens.**
